Submerged Cultural Resources Site Report

NOQUEBAY

APOSTLE ISLANDS NATIONAL LAKESHORE

**SUBMERGED CULTURAL RESOURCES SITE REPORT:
NOQUEBAY**

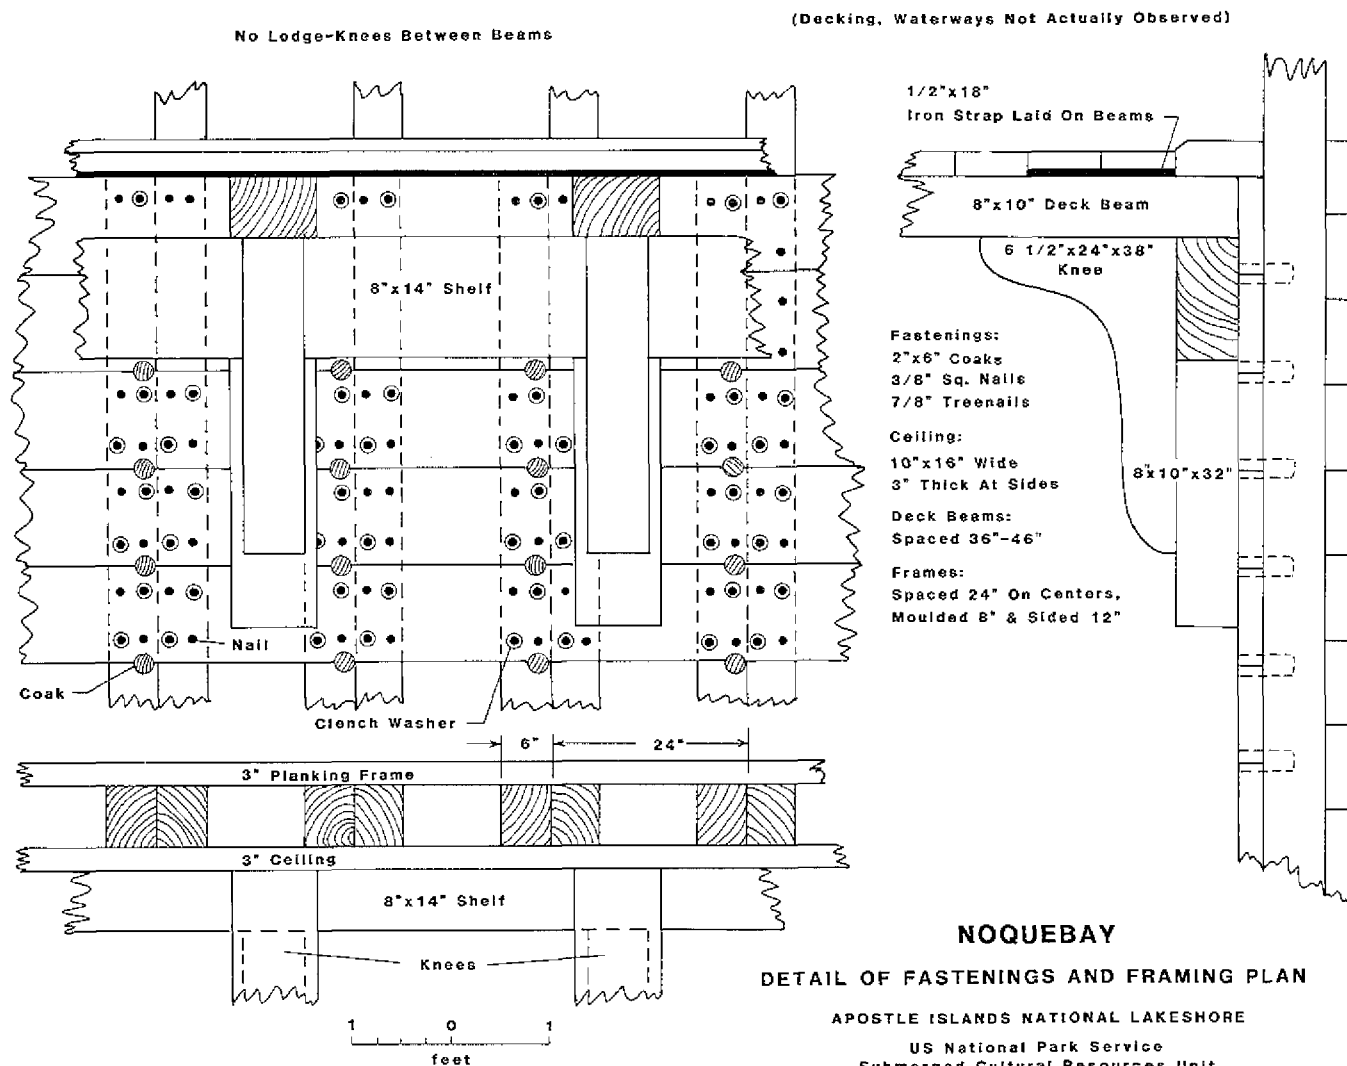
Figure 11: Detail of Fastenings and Framing Plan

the bilge ceiling. These are wooden "dowels" which are laid into the surface of two adjoining timbers to prevent slipping or sliding endways, i.e., longitudinally. The bilge ceiling has 2-inch coaks, spaced on 24-inch centers, falling between frames. The bilge ceiling fasteners differ from the ceiling on the bottom only in that the double fasteners alternately have 1-inch diameter clench washers (Figure 11). This fastening pattern begins at the turn of the bilge and continues to the main deck.

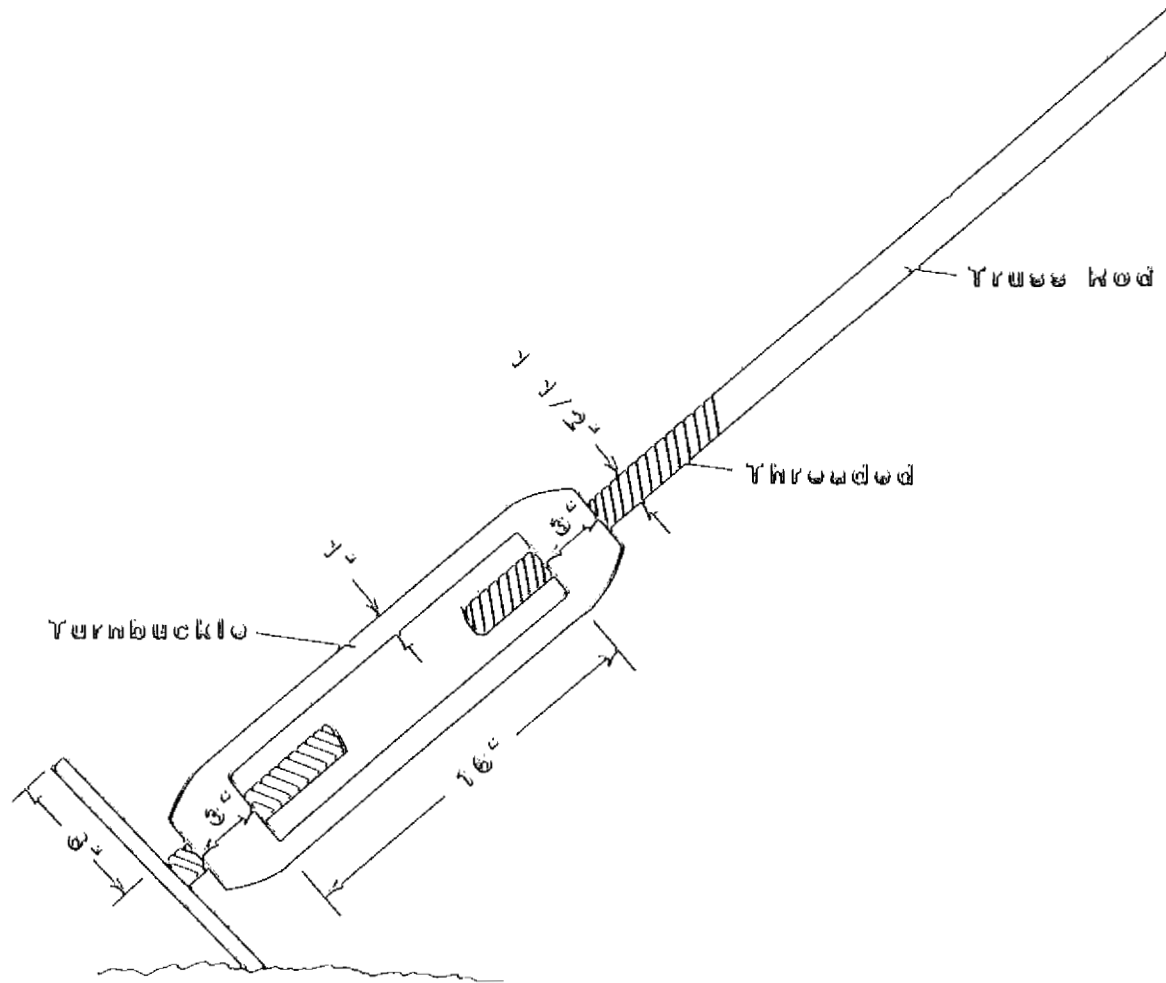
Figure 12: Detail of Turnbuckles

At base line point 160, adjacent to the starboard sister keelson, a 25-foot section of truss rod begins. This section of rod, with a 22-by-4-inch turnbuckle, is one of several represented on the site. The rod is uniformly 1-1/2 inches in diameter; where it articulates with the turnbuckle it is threaded to facilitate connecting and adjustment. There are 5 articulated turnbuckles exposed on the site that are either 22 inches or 24 inches long. Two of the turnbuckles are 24 inches by 4-1/2 inches and three are 22 inches by 5-1/2 inches. It is probable that at least one additional turnbuckle would have been used on this vessel, making a total of six.

In some of the cases the rod and turnbuckles also had flat plates in association. The turnbuckle on the starboard side near base line point 165 has such a plate. It is 4 feet from the end of the turnbuckle and is 6 by 5-1/2 by 1 inch. The plate is not perpendicular to the rod, rather it is at a slight angle to the rod. Two other similar plates were found on sections of rod, one of which is in association with a turnbuckle. The plate and turnbuckle, located on the starboard sister keelson near base line point 202, is reproduced in Figure 12. The plate with this turnbuckle is the same size as the plate at base line point 165, however this plate is only 1 inch from the turnbuckle and is perpendicular to it. One additional plate

The truss rod was designed to reduce longitudinal hogging of the hull. The turnbuckles were used to tighten sections of rod, pulling the vessel bow and stern up. It appears that the rod passed up through the deck near the bow, similar to truss rod found on another Great Lakes schooner WILLIE LOUITT (Plate 11), ran down the deck to the stern and then below again. The plates found on rod were probably for deck reinforcement and protection at the points where the rod passed through the deck planking. Internal strengthening was particularly important on NOQUEBAY, since she had no mainmast and no forestays connecting the remaining masts (see historic photo, Plate 3). If NOQUEBAY had continuous forestays they would have provided some additional longitudinal strength to the hull, perhaps without the necessity for a truss rod. Further, the relatively light planking on this vessel's hull also contributed to the need for longitudinal strengthening (C. P. Labadie, personal communication).

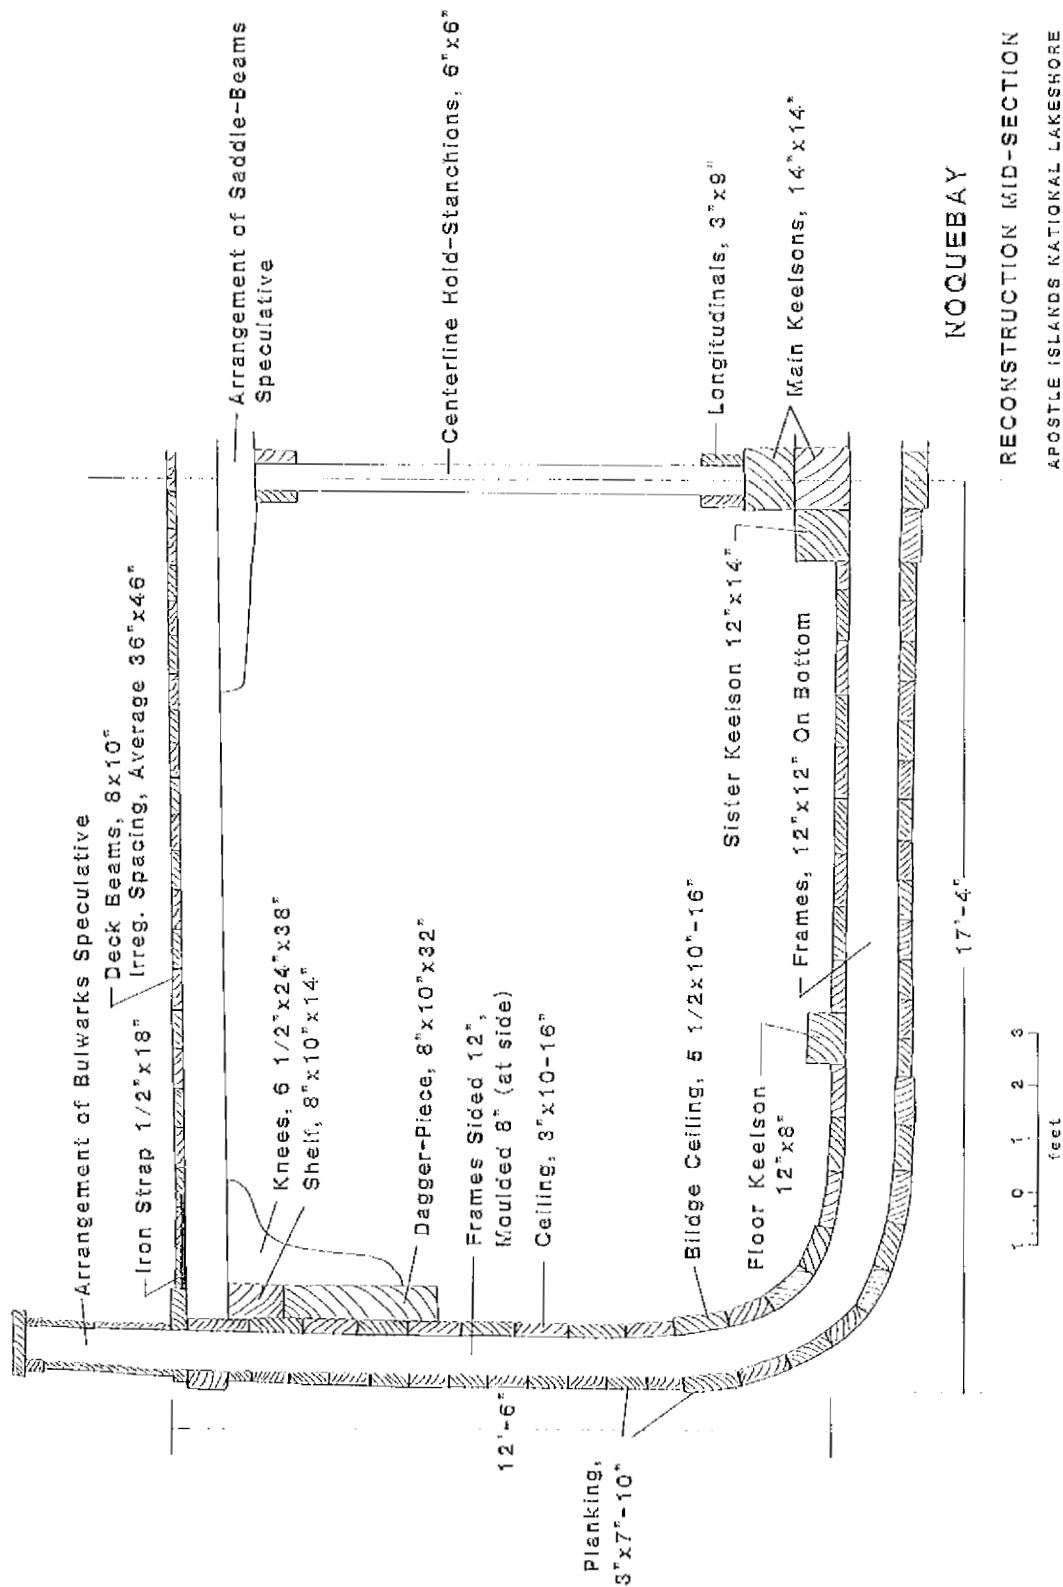
Figure 13: Hull Cross Section

Transverse strains cause the sides of a vessel to bow out or in. Transverse strains are much greater than longitudinal strains and as soon as a vessel moves, inclines, or pitches and rolls, transverse water pressure works to alter the shape of the vessel. If the framing, especially at connections between deck beams and side framing, is not strong enough or properly fastened, the knees, as well as the framing of the decks and bilges, will begin to loosen (Desmond 1919:35). In an effort to deal with this problem, the builders used a wide strap (Plate 13), running longitudinally at the level of the main deck. The strap was probably placed directly over the deck beams, at the level of the decking, and tied into the deck beams and knees by fasteners (Figure 13).

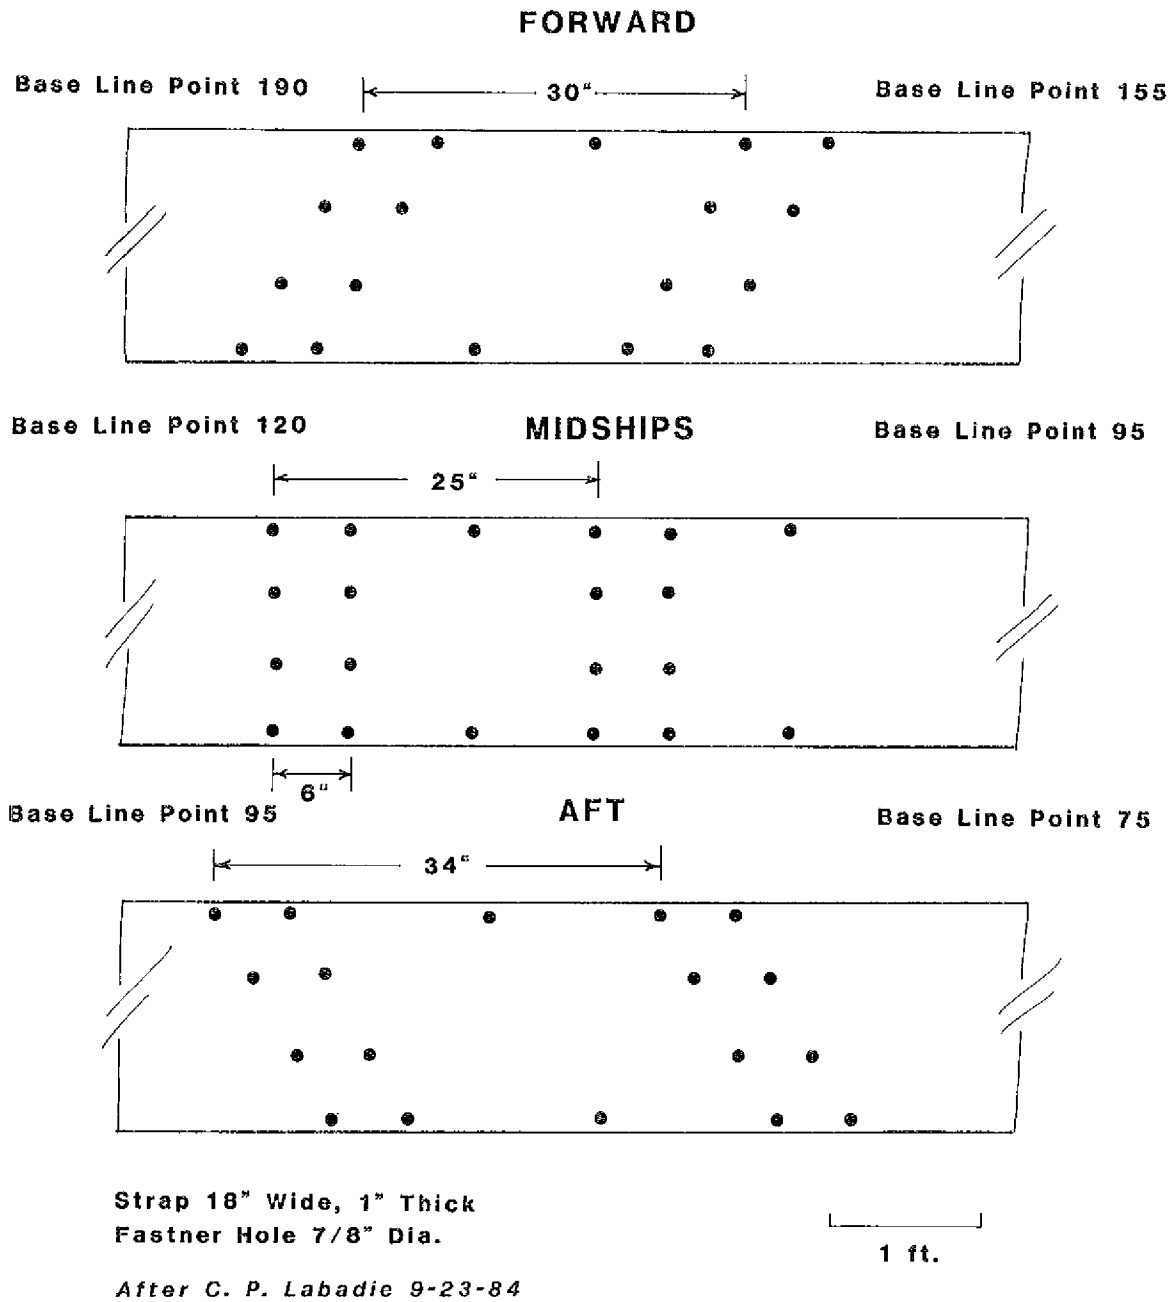
Figure 14: Hogging Strap Detail

One section of hogging strap, lying on the starboard side of the ship's bottom, stretches from the exposed frames at the turn of the bilge, across the starboard floor keelson, to the starboard sister keelson. It is approximately 44 feet long, overall, and is 18 inches wide by 1/2 thick. The 7/8-inch diameter fastener holes match exactly the diameter of the nails found sticking out of the extant knees on the starboard side section. Further, the spacing and angle of these holes correspond to the spacing and angle of the knees verifying that the strap was tied to this feature (Figure 14).
